**HOUSATONIC RIVER BASIN
DALTON, MASSACHUSETTS**

**EGYPT RESERVOIR DAM
MA 01063**

**PHASE I INSPECTION REPORT
NATIONAL DAM INSPECTION PROGRAM**

MARCH, 1981

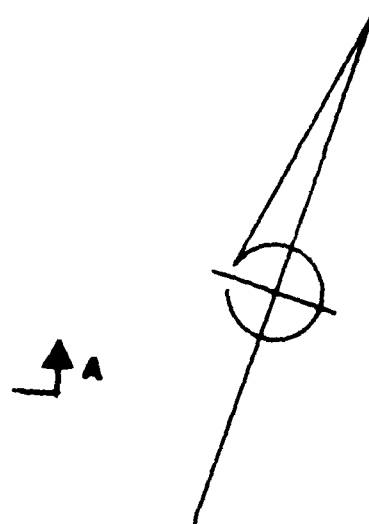
APPENDIX B FIGURE 1 GENERAL PLAN

SPILLWAY CHUTE
Walls cracked,
crushed, displaced, and
separated from floor.
Floor is cracked,
undermined, uplifted

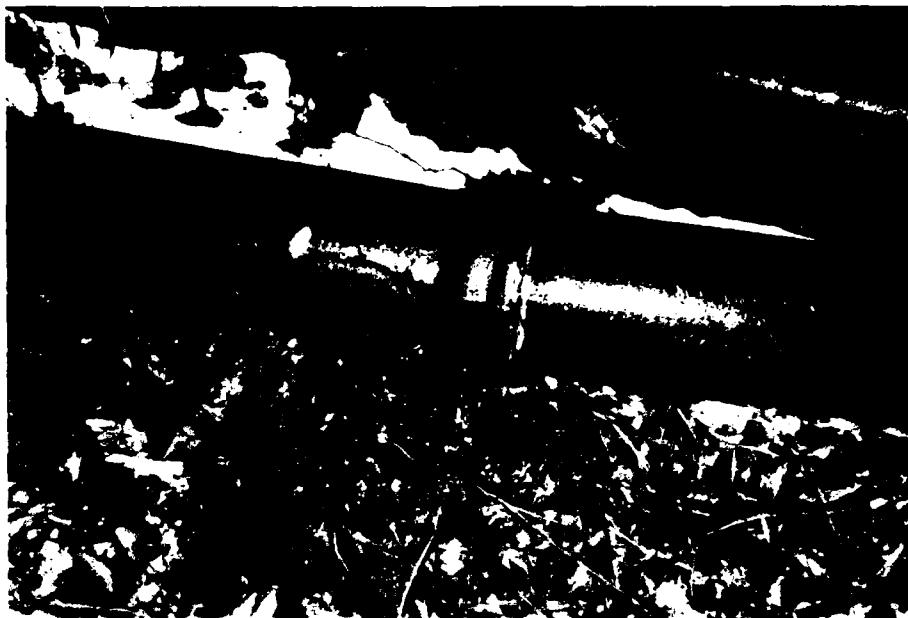
The purpose of the easterly conduit is not known. It may be capped at its upstream end. The source of seepage out of this conduit requires further investigation. The westerly conduit, which is regulated by the gate valve, is cracked and is leaking near its outlet. The ground in this area is very soft. There are no headwalls or other discharge structures for either the easterly or westerly conduits. The reproduction of the original construction plan indicates that both conduits are supported by piers of unknown type and calls for a common headwall at the downstream ends of the conduits. The plan shows no anti-seep collars for either conduit but indicates that the pipes pass through the timber plank core wall.

Photograph 15 - View of crack in regulating outlet conduit. Note leakage from crack.
